The Assessment of Water, Sanitary, and Hygienic Conditions in the Kvemo Kartli Region

Final Report

Prepared by Simon Gabrichidze

January 2018

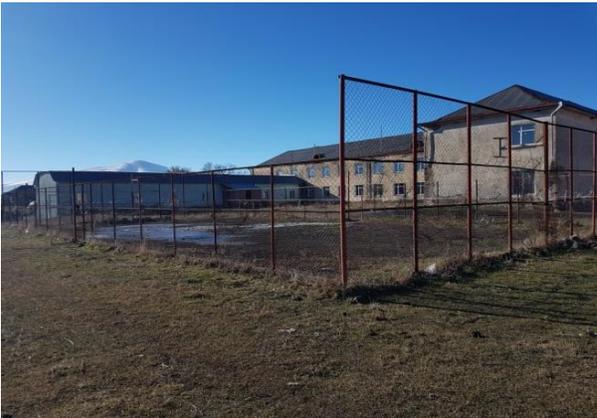
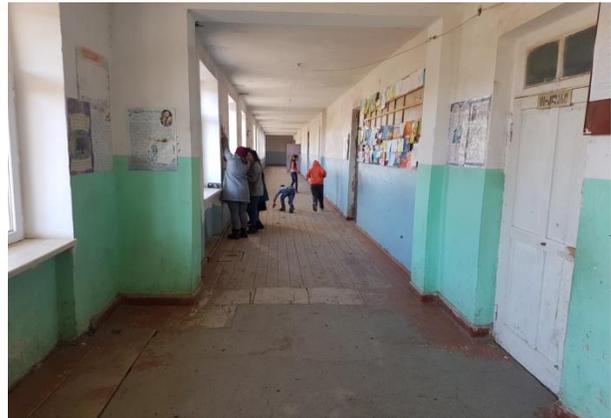
1. All significant problems concerning sanitary and hygienic conditions are related to the situation in the lavatories. There is a “pit-type” lavatory in the area outside of school including three units in a row for boys, a separate one for teachers, and a separate one for girls. The toilet is not adapted for people with disabilities and younger children. The sanitary conditions of the existing lavatories in no way complies with the existing sanitary standards - it is not built with tile, which would make it possible to clean it, and is never disinfected at all. Furthermore, village residents also use the school lavatory apart from the students, staff, as the school area is not enclosed, and a ceremonial hall operates close to school.

- Due to strict climate conditions in the region it is necessary to install toilet facilities in the school building where adequate opportunities for hand washing and proper sanitary conditions will be ensured.

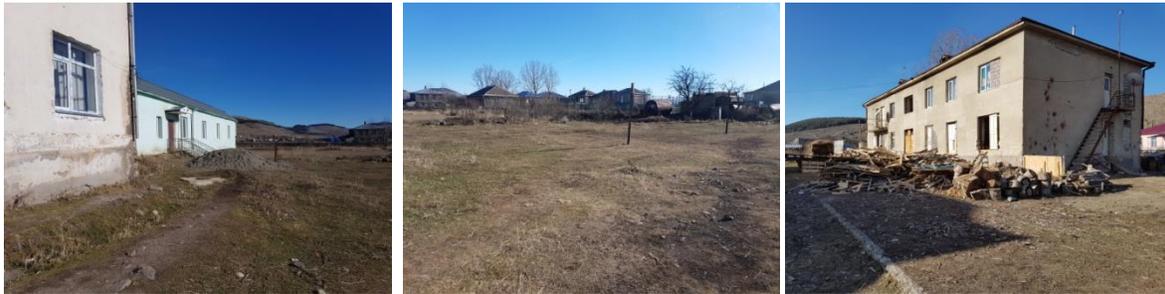
2. The school area is not enclosed which makes it possible for intruders to freely access and pollute the area, contributing to the already poor sanitary conditions of the yard.

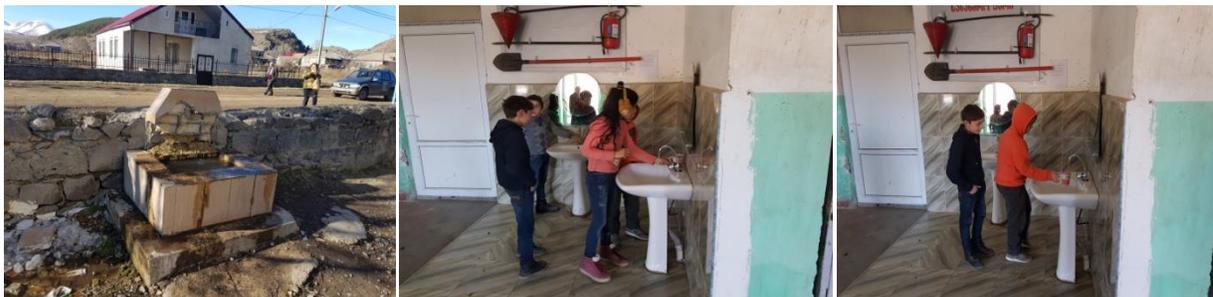
4. It is unlikely that the water quality is safe for health. According to the school administration, the water is undrinkable based on its bacteriological data. In addition, school students use utensils of common use for drinking purposes which contributes to the spread of infections. Based on the aforementioned reasons, intestinal infectious diseases are commonplace among school students (these are mainly accompanied by diarrhoea).

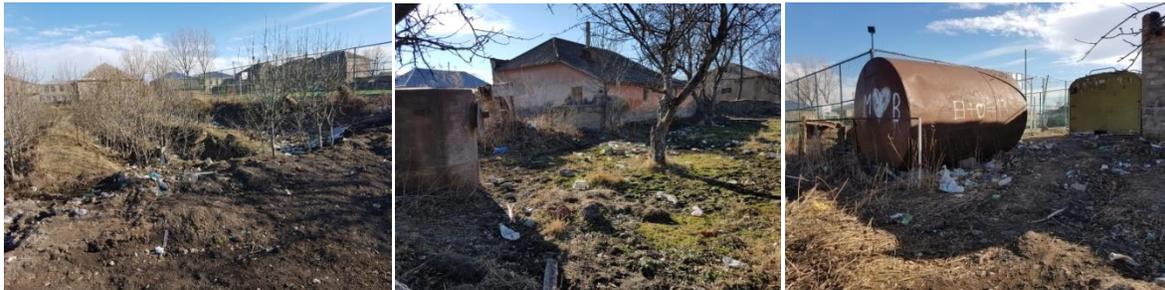
7. An illegal landfill where village residents dump their solid household waste is located on the school premises, which creates significant unsanitary conditions in the territory. The school itself disposes and burns waste on its own territory almost on a daily basis (based on word of mouth). There is only one waste container in the school building.

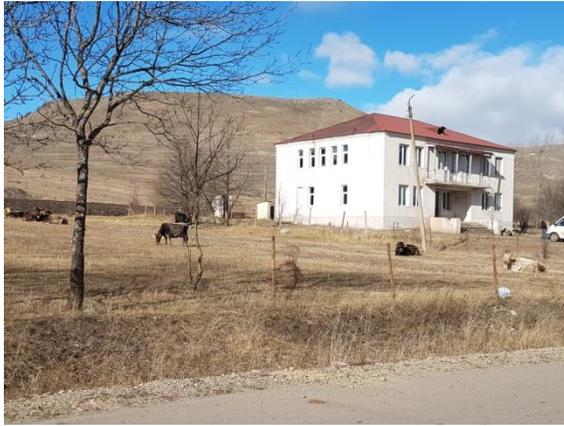
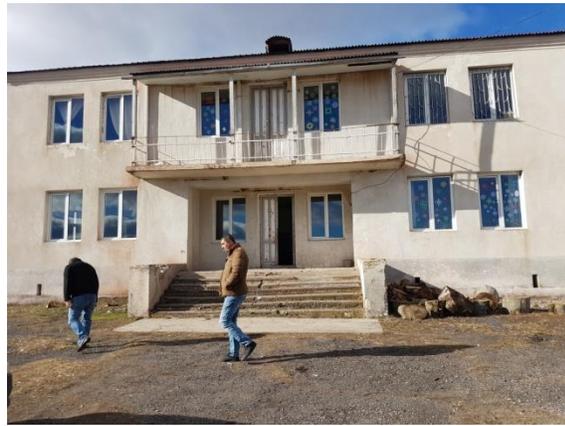
1. The school area is not fenced off which makes it possible for intruders and livestock (and also dogs) to freely enter and litter the school area. These factors cause poor sanitary conditions and pose a threat to the school's students and staff.

2. There's a serious problem regarding toilets – there is a "pit" type lavatory with a cabin where 1 unit is located and intended for common use (both students and teachers). The lavatory is located at a 10 m distance from the school building. It is not adapted for younger and children with special needs. The existing sanitary conditions of the lavatory in no way meets the existing requirements: it is not built with tile, which would make it possible to clean it, and is not being disinfected. There are two more lavatories (pit-type/with a wooden cabin) that do not function. Furthermore, the dilapidated lavatory is open and easily accessible to children, thus posing a risk to their health.

- Due to strict climate conditions in the region it is necessary to install toilet facilities in the school building where adequate opportunities for hand washing and proper sanitary conditions will be ensured. At the very least, the existing toilets must be repaired (all three toilets must be functioning and be differentiated: a separate toilet must be designed for teachers, another one for the boys and the other one for the girls). Also, adaptation of toilet facilities to the needs of younger children and students with special needs must be considered.

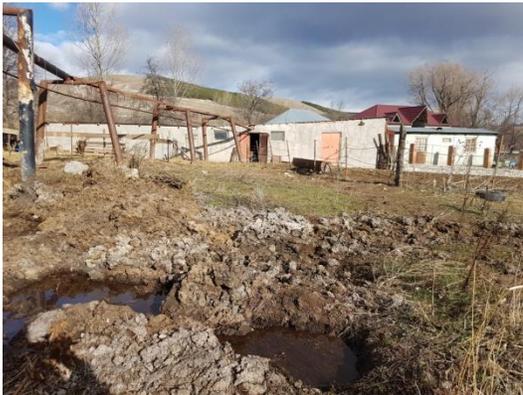
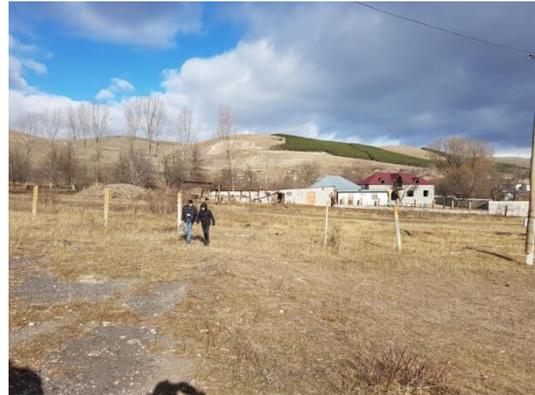
3. Due to the lack of hand-washing facilities in the school, water is brought to school by teachers and children in dispensable plastic bottles/buckets from the water tap of a local resident living in the area adjacent to school. The area surrounding the school area is significantly contaminated with manure which poses a great risk to the school community in terms of becoming ill with an infectious disease. Also, there is a dog in the school yard that runs freely. Therefore, there is also a risk of the school's students and staff getting bitten by the dog (with a potential risk of being infected with rabies).

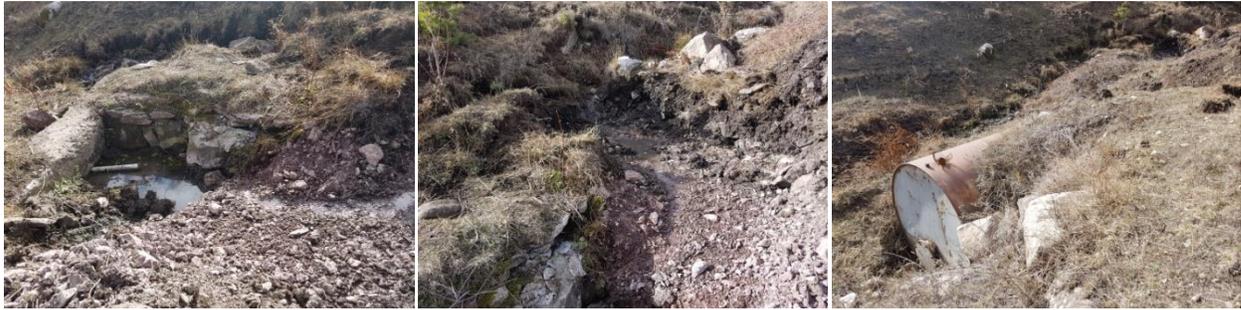
4. At the same time, it is unlikely that the quality of the existing water meets the drinkable water safety standards. Monitoring of headworks has demonstrated that it has been constructed in violation of sanitary rules and is absolutely exposed to contamination. This opinion is shared by the school administration who state that water is undrinkable based on its bacteriological data.
5. There is no special program at school to teach students about hygiene issues. Only occasionally a teacher will discuss hygiene-related issues with students, but it may or may not be comprehensive. There are also no printed informational materials concerning sanitation and hygiene issues providing students with information that is essential and important for their health. Thus, school students have no relevant knowledge of the rules of personal hygiene.

6. Some students (mostly younger children) bring drinkable water from home in disposable plastic (PET) bottles. As a result of the inspection during the visit, it turned out that none of the bottles were designed for drinking. Moreover, these bottles are disposable. Pouring any liquid (including water) into it is detrimental to health because of the harmful substances emitted in the bottles, especially with long-term use. The examination of children’s bottles at school clearly revealed that many of them were being used for a long period of time.

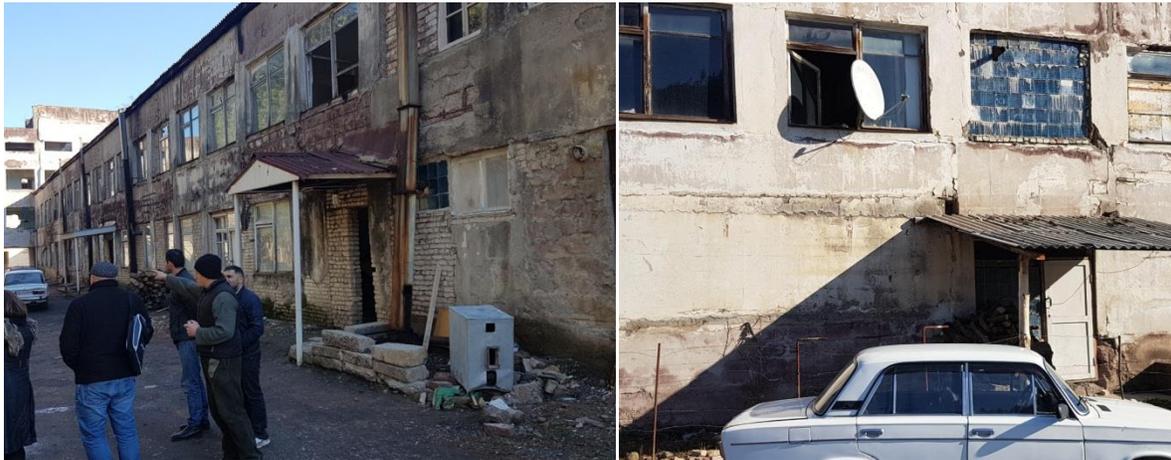
1. A simple check-up reveals that water, sanitary and hygiene conditions in the buildings do not meet the requirements/standards for a living space.
2. Residents are not supplied with adequate water. The main tap used by the majority of the residents is located in the yard (water is brought into the yard via a water pipe) where water runs down in small amounts. In addition, its organoleptic indicators mostly do not meet the water drinkability standards. Also, there are no positive results from a bacteriological study of the water.
3. Only 5 out of 22 apartments have water. Due to the scarcity of water, residents use it in turns. Due to the low pressure of the water, the residents on the second floor are hardly able to use the water in their apartment.

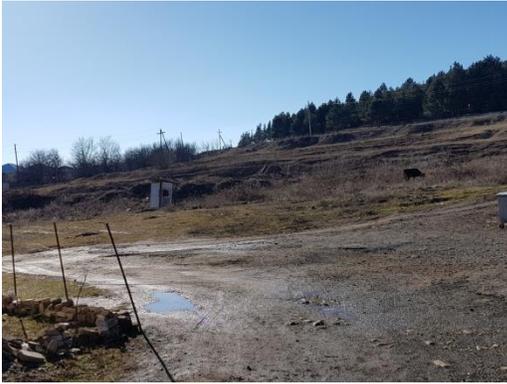
5. Two “pit” type lavatories with wooden cabins are installed in the yard of the building and their sanitary conditions are unsatisfactory with no regular cleaning or disinfection that takes place. Lavatories were not overflowing on the day of the visit.

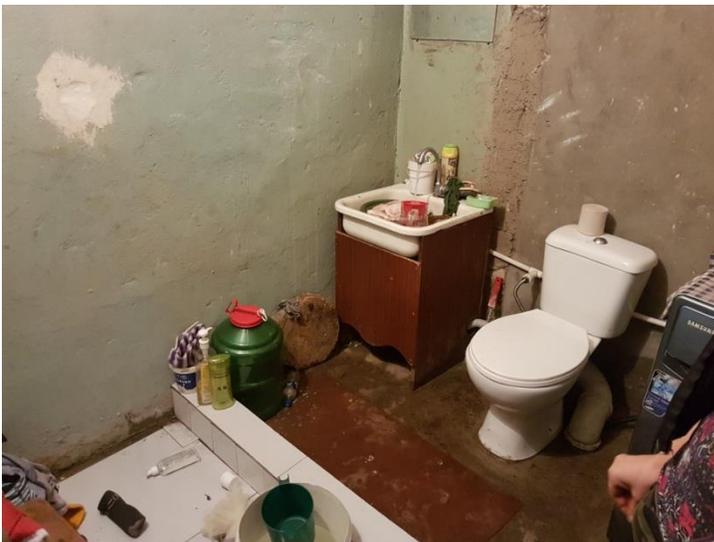
6. Five families also have toilet facilities in the apartments. However, their use is limited due to the scarcity of water and unfavourable sanitary and hygiene conditions were observed there.

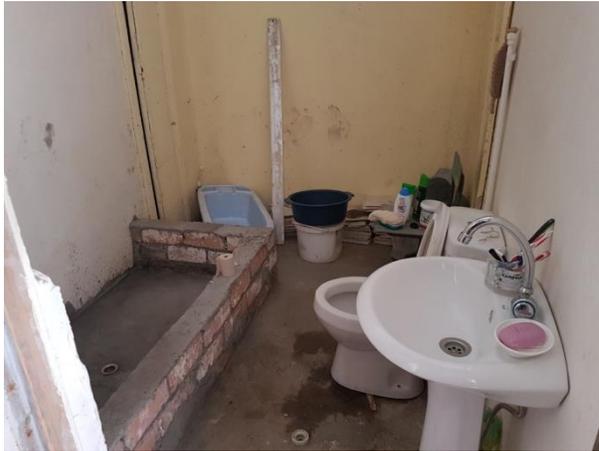
7. Five families also have wash basins (bathrooms) in their apartments, though their regular use is also a problem due to the scarcity of water (during the visit even “solid” soap was observed near the washbasins).

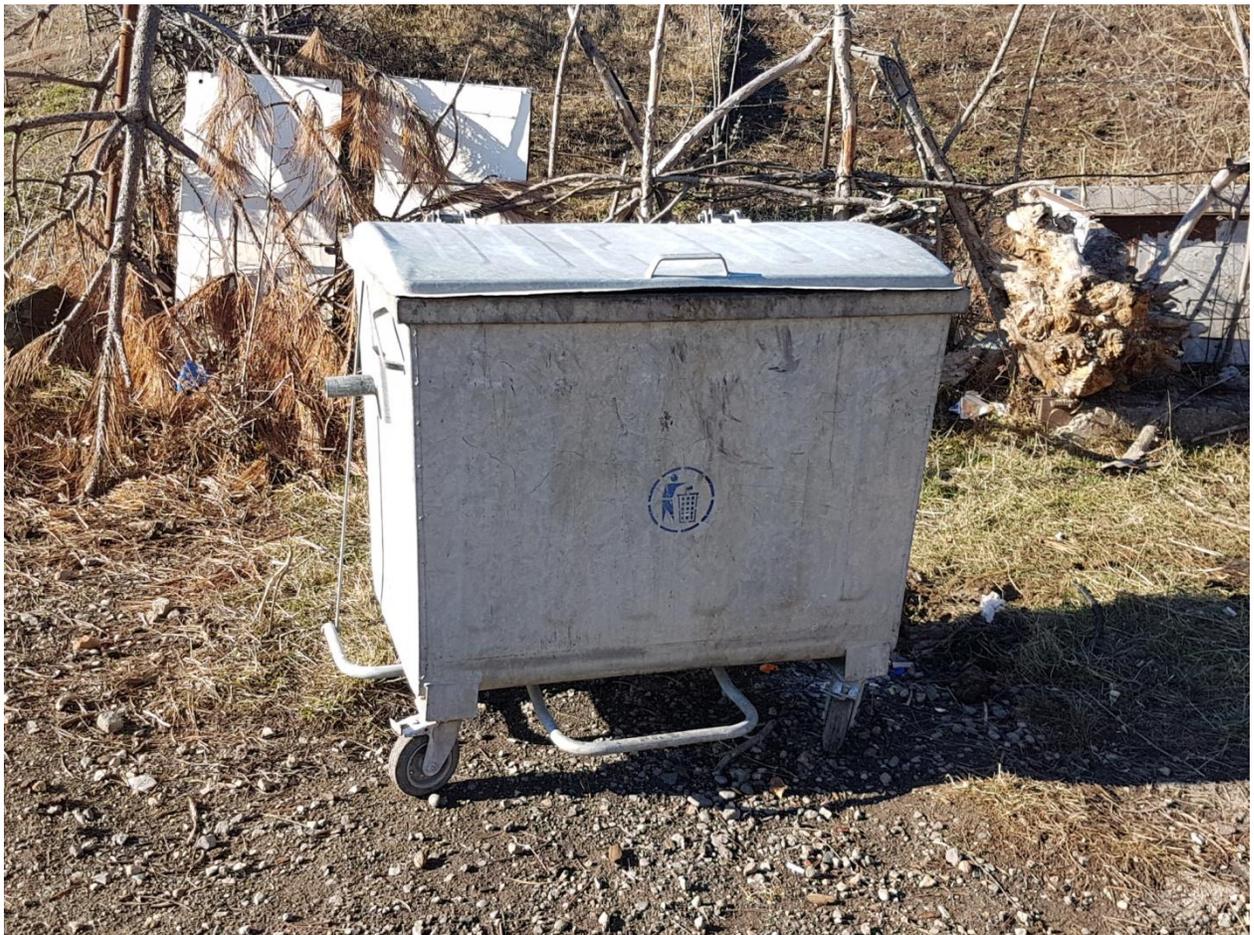
9. There is a “solid waste” container in the yard emptied by a special collection service twice a week. The container was not overflowing on the day of visit and it was properly covered with a lid.

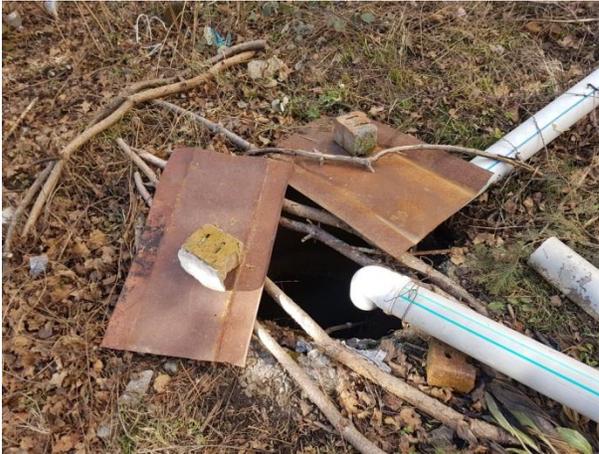
10. Sewage and drainage system is a major problem. Practically two days a week the sewage system is stuck and the toilets in the apartments are unusable. The residents have to wait for the sewage pipes to self-drain. The sewage collector is not properly covered. Due to lack of a drainage system, water flows into both

the common-use basement and the apartments of the first floor during heavy rains and creates conditions unfit for living.

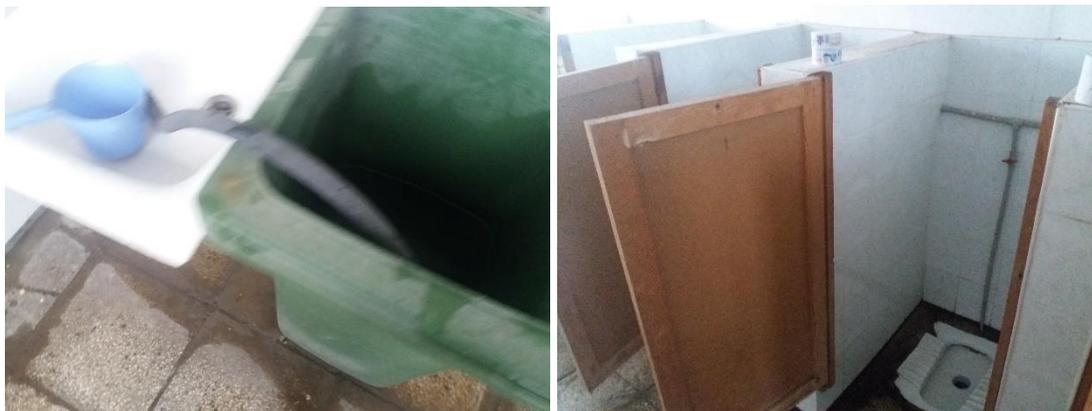
1. The main problem at school has to do with malfunctioning toilet facilities. Six toilets have been installed on all four floors of the building with a separate toilet for teachers to use. Five cleaning personnel clean all six toilets. The toilets are not adapted for children with special needs. The current sanitary situation in the toilets fail to meet the existing sanitary standards: an unpleasant odour can be smelled from the school entrance which is the result of a malfunctioning sewage system. Also, the sewage system clogs frequently making it impossible to flush, which, other than being a source of disease, makes children abstain from using the toilet.

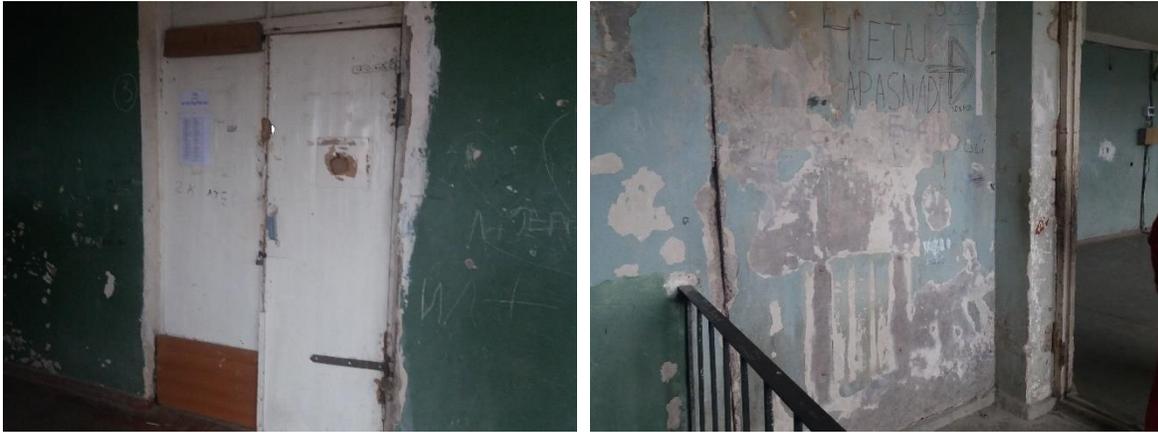
5. Time-worn doors of a classroom, cracked walls and broken furniture strike the eye during the observation. Students state this as one of the most unpleasant aspects of their school.

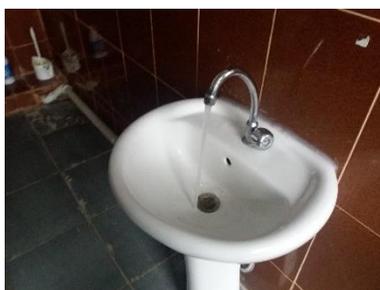
1. No waste bins are installed in the village of Ghisilaghjlo. The illegal dumpsite near the kindergarten, used by the kindergarten itself, is a source of pollution.
2. Boiled water is used for drinking purposes in the kindergarten, since the latest laboratory analyses have shown that the water was undrinkable. It should also be noted that frequent consumption of boiled water negatively affects health.
3. During the observation, a damaged toilet was discovered where water ran out of it ceaselessly.

- Illegal dumpsites must be closed and waste bins must be installed in the village.
- A kindergarten must have its own waste bin which should be emptied by a municipal service.
- A water dispenser must be installed in the kindergarten to avoid the daily consumption of boiled water.
- An electric system should be repaired so that there are no power outages.

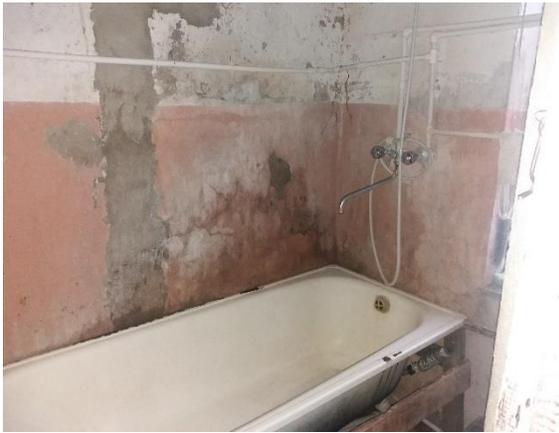
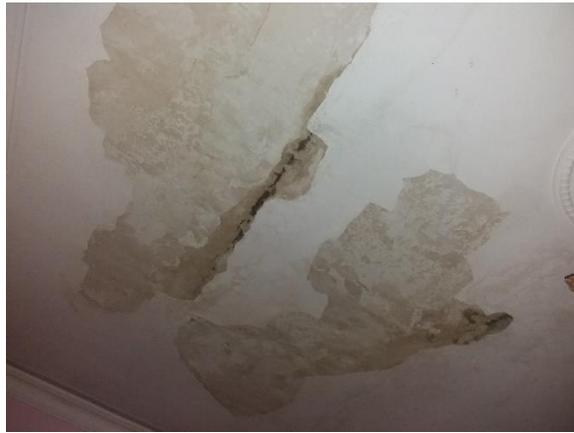
1. Observation clearly demonstrated that the condition of the Elevator settlement in no way meets acceptable living standards. There are hygiene and sanitary problems and a faulty water supply system.

- The building is in a critical condition and unhygienic state. The residents need to change their current living environment with better WASH conditions.
- The cow-house is to be shut down or transferred to a different location which should be advocated by the municipal government.
- Elevator residents must be given access to information on hygiene and sanitation.
- The repair of the building by the solicitation of the Marneuli municipal government.
- Implementation of cleaning activities in the building and in the yard, putting into order and disinfection of the pit toilets.
- A laboratory analysis of water is to be conducted in the Elevator settlement to determine its suitability.

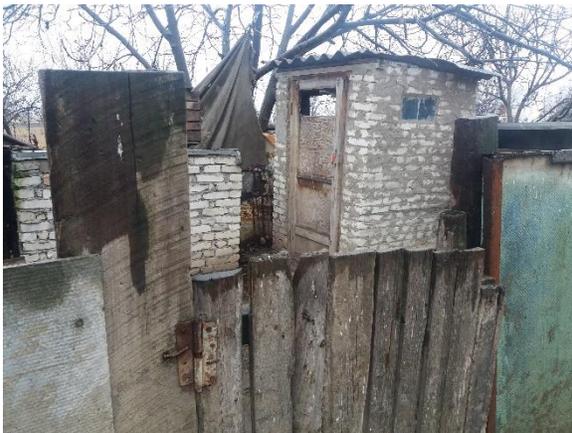
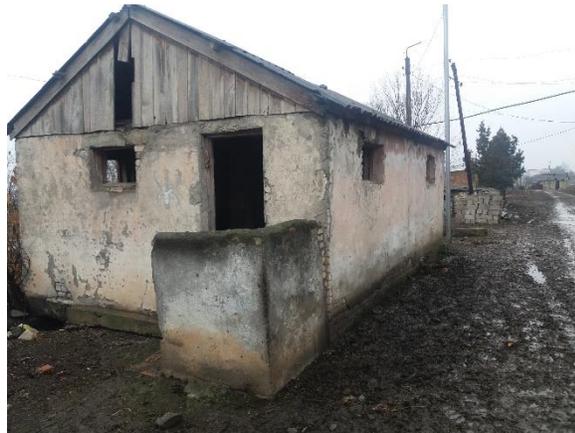
3. There are “pit toilets” set up in the yard of the settlement (with wooden cabins in certain cases). Some families have their own pit toilets, while other residents use common-use toilets with unacceptable sanitary conditions.

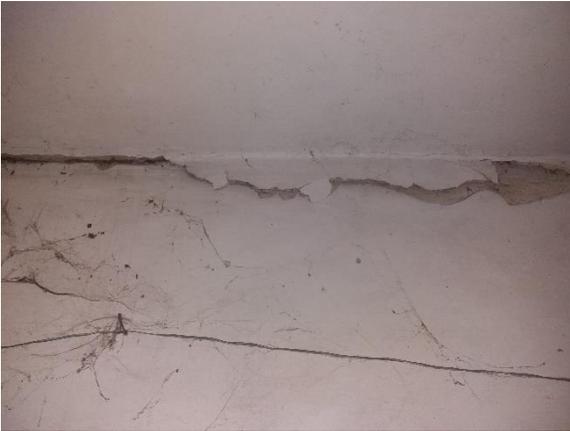
5. There is a cow-house on the territory of the settlement which is a serious source of disease (i.e. fecal matter, insects, etc.) Cattle freely walk around in the yard of the Elevator settlement as well.
6. The settlement has no special container for solid waste. Litter is collected in a special bucket installed in a bunker. This factor, apart from the wandering cattle, creates unsanitary conditions and could potentially lead to the spread of serious diseases.
7. Floors of the building are cleaned by the residents themselves. The survey shows that only water and no chemical detergents are used in the cleaning process.
8. Condition of apartments (living conditions) are not safe for human health. The existing moisture, cold and uncleanness makes children and the elderly vulnerable to disease.

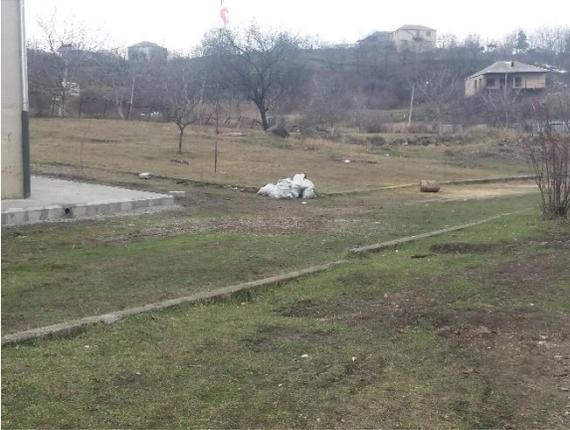
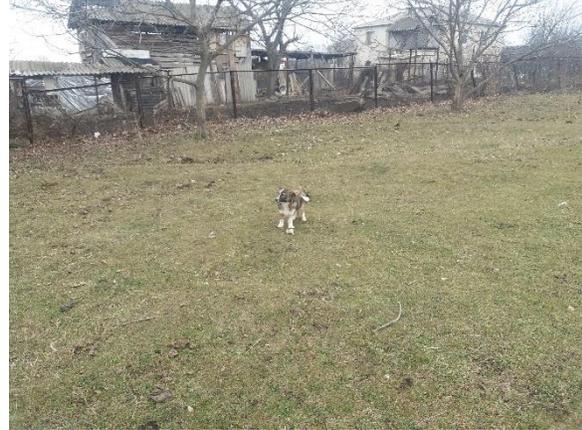
1. Livestock and dogs have easy access to the school territory which is not enclosed by a fence. This factor contributes to school littering and creates the risk of children getting bitten or attacked.

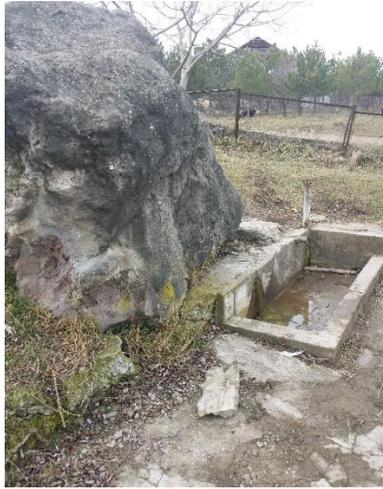
8. There is an open stadium in the schoolyard which is the only entertainment for village children, though it gets muddy on rainy days.

9. Water debit from the school tap is very low and is apt to frequent interruptions.
10. No educational materials have been distributed and no training has been conducted at school concerning any WASH issues.
11. Waste is accumulated in the school yard, which, taking into consideration the damaged fence, could create a risk of scattering waste all over the school territory and the potential spread of diseases.

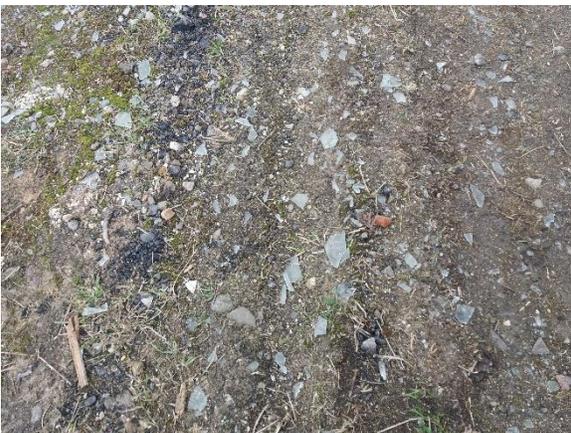
12. During the observation, excrements and glass fragments were found in the school yard.

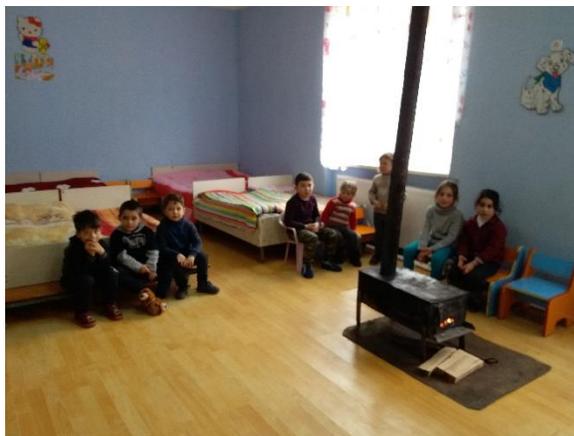
- Although central heating is functioning in the kindergarten, the village is not supplied with gas, so the building is heated by wood and it is cold in several rooms.

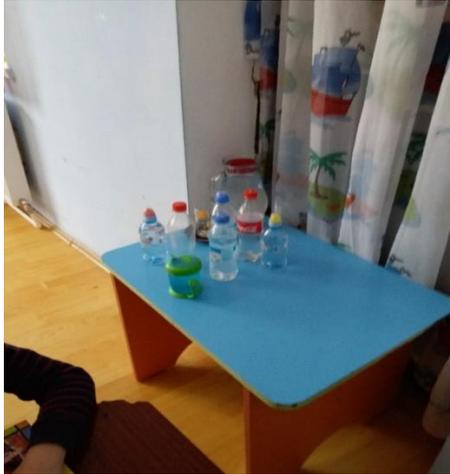
- Children bring water in disposable plastic bottles from home, which is unacceptable.

- There is absolutely no literature on WASH issues in the kindergarten.
- Waste is illegally dumped in a dumpsite in a ravine next to the kindergarten.
